# COMBINED FIRE AND HEALTH & SAFETY RISK ASSESSMENT.

| Address of premises: | Chopin Mews,<br>Mazurek Way,<br>Swindon,<br>SN25 1TS |
| Date of fire risk assessment: | 5 <sup>th</sup> March 2026 |

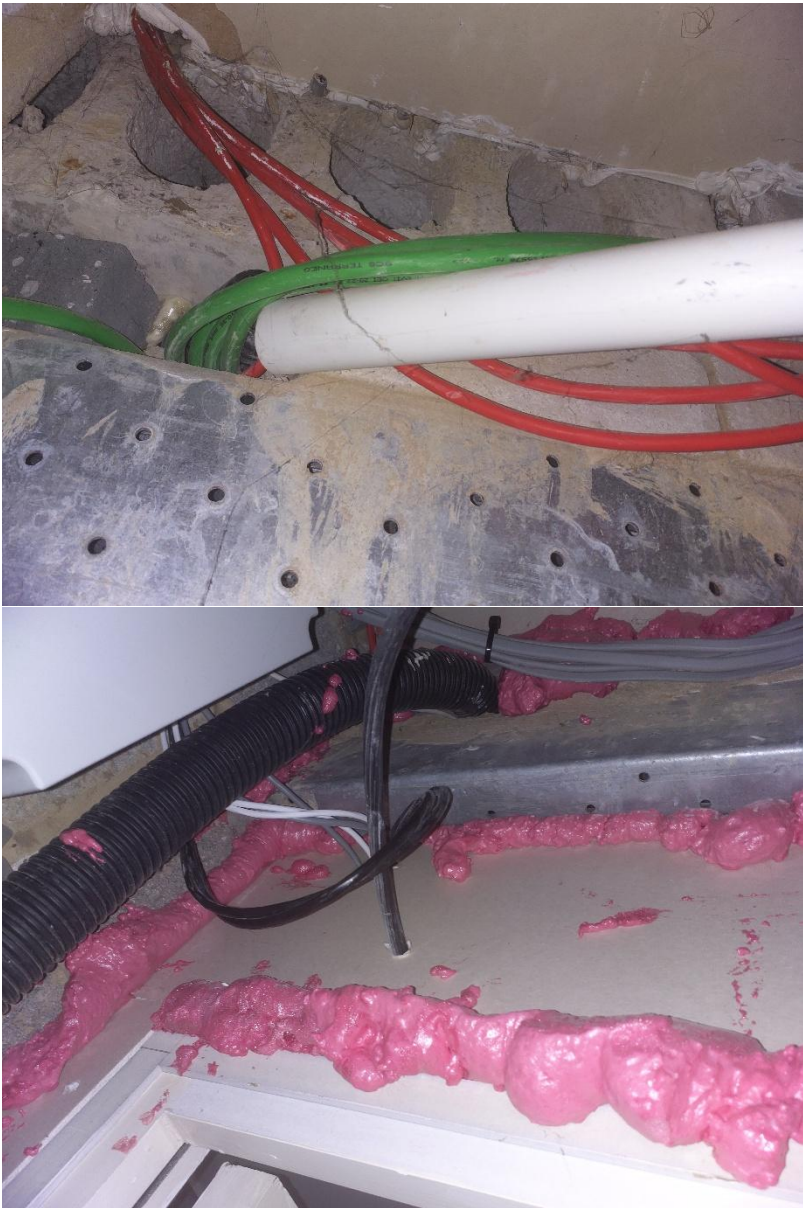
| <p>It was noted during this fire risk assessment that the electrical intake cupboards in all communal areas had an excessive use of pink foam. This integrity of this compound cannot be verified to fire stop large breaches in the compartmentation due to the changes in viscosity. It is therefore recommended that the RP instructs a suitably qualified and competent contractor to install a fire-resistant compound capable of providing a minimum of 30 minutes fire resistance for large breaches. This should then be certified.</p> <p>Additionally, it was noted during this fire risk assessment that the fire stopping within the electrical cupboards of communal area 1 was poor. It is recommended that the RP instructs a suitably qualified and competent contractor to repair all the breaches with a suitable compound capable of providing a minimum of 30 minutes fire resistance to protect the means of escape. This should then be certified.</p> | | |

| <p>02</p> | <p>It was noted during this fire risk assessment that the electrical intake cupboards in all communal areas had an excessive use of pink foam. This integrity of this compound cannot be verified to fire stop large breaches in the compartmentation due to the changes in viscosity. It is therefore recommended that the RP instructs a suitably qualified and competent contractor to install a fire-resistant compound capable of providing a minimum of 30 minutes fire resistance for large breaches. This should then be certified.</p> <p>Additionally, it was noted during this fire risk assessment that the fire stopping within the electrical cupboards of communal area 1 was poor. It is recommended that the RP instructs a suitably qualified and competent contractor to repair all the breaches with a suitable compound capable of providing a minimum of 30 minutes fire resistance to protect the means of escape. This should then be certified.</p> | <p>2</p> | <p>B</p> | <p>Action required</p> <p>Contractor to investigate further.</p> |
